Electroless Copper Process Control using Back and Frontlight Evaluation

Don Cleary

The article is currently published at PCB 007 website, November 2010

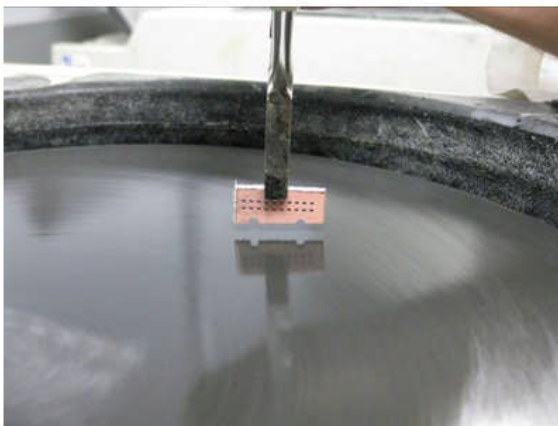
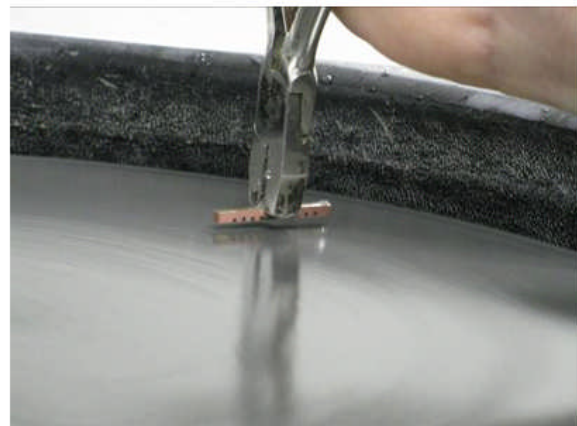
Figure 1: Sample Preparation

Back side rough grind

Front side rough grind

Once the coupon is removed from the panel, it may be prepared by either using a diamond saw to cut into the holes, or by grinding the coupon down using a wet grinding wheel. Rough grind to the middle of the holes, using either 120 or 240 grit paper, and remove any debris around the holes with 400 or 600 grit paper. When grinding coupons, it is best to use a small pair of smooth faced pliers to hold the coupons, as shown in Figure 1.

First grind down to 1-2 mm from the back of the hole to be inspected, then flip the coupon over and grip the 1-2 mm area with the pliers, being careful keep the pliers away from the holes. After the sample has been prepared, rinse thoroughly with water and dry with compressed air.

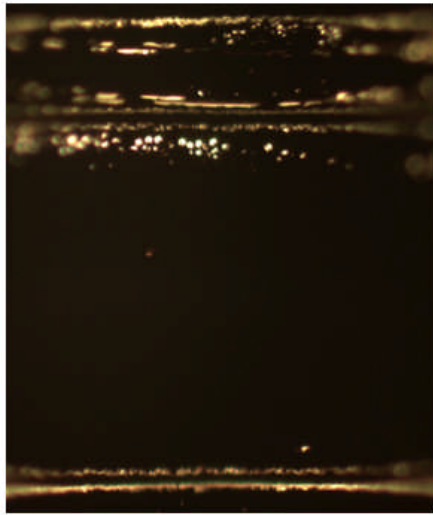
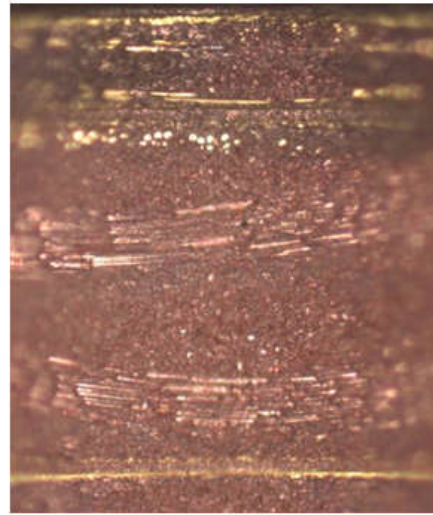
Backlight

Frontlight

Figure 4: Backlight and Frontlight Images Showing ROP, GTV, TGV.

ROP – “Ring of Pearls”

GTV – “Glass Tip Voids”

TGV – “Transverse Glass Voids”

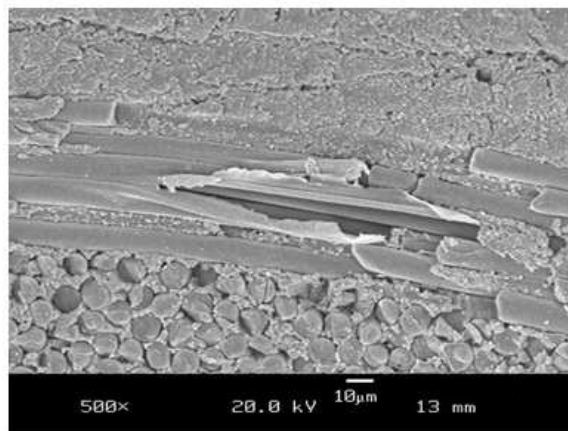
Figure 5: SEM of “Pop Off” (PO) on a transverse glass bundle

When the electroless copper deposit fails to adhere to the glass and starts to crack, it may eventually “pop off”, leading to a TGV. Since TGV can be caused by several different root causes, evaluation for “pop off” can provide additional information about the defect mode.

Typical Causes for “Pop Off” are over conditioning and catalyzation, however the electroless copper thickness and glass thickness can also play a role in causing this defect. The thicker the electroless copper, the more likely it is to “pop off” the glass, due to the stress within the copper deposit. In addition, thicker glass is more likely to show “pop off” compared to thinner glass, due to the increased surface area of the thicker glass. There can be occasions when, upon examination of the glass using frontlight, poor adhesion or buckling of the electroless copper can be seen, but the backlight is not affected. This weak bond between the electroless copper and glass is an indicator of the potential for TGV on other areas of the panel.

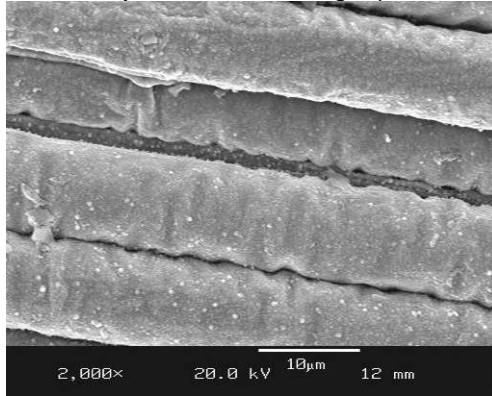
Figure 6: SEM of wrinkling on a transverse glass bundle

In some cases, rather than the electroless copper popping off the glass, the copper has a wrinkled appearance, although many times, no glass voiding can be seen in the coupon. Therefore the presence of wrinkling is worth noting because it is an indication of less than perfect glass adhesion and, if seen, it may be useful to check additional samples to see if any evidence of voiding is present.

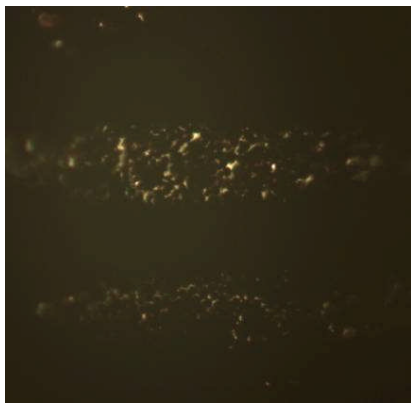
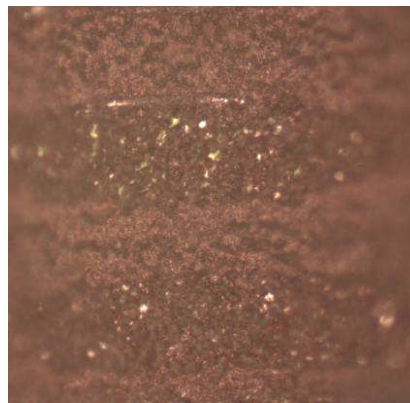
Backlight

Frontlight

Figure 7: Backlight and Frontlight Images Showing TAG
The areas around the glass tips have incomplete electroless copper coverage.

This defect occurs predominantly around glass tips, and is frequently mistaken for GTV during back light examinations. Upon closer evaluation of the void areas using frontlight, you can clearly see the light is coming through from areas around or in between the glass, rather than the glass area itself.

This defect is more often seen on lower Tg than high Tg materials, due to their higher epoxy removal rates. The more aggressive the desmear process, the more likely TAG defects are to occur. Additionally, thinner electroless copper deposits are more susceptible to TAG.

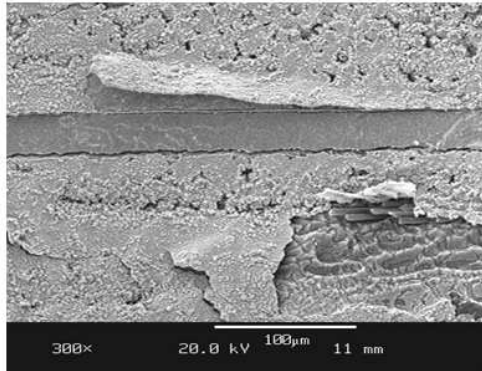
Figure 8: SEM of the electroless copper peeling (PL) from epoxy areas of a holewall

This defect occurs on epoxy areas and is similar to PO, except that it occurs on the epoxy portion of the hole.

Typical causes for “PL” are over conditioning and catalyzation. However some laminates are more prone to this defect, due to lack of texturing during the desmear process. While higher Tg materials are typically harder to texture than lower Tg materials, not all materials follow this pattern. Other factors that can impact texturing and PL are the type of epoxy used and whether fillers are used. Flex materials can also be very difficult to texture and are prone to PL and blisters (EB).

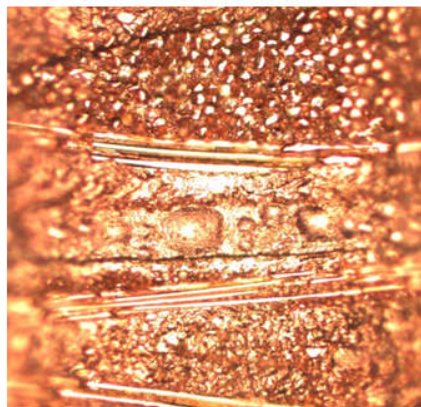
Figure 9: Frontlight of the electroless copper blistering off the copper inner layers in a hole

This defect can occur on either copper inner layers, or the epoxy portions of the hole wall. In either case they have the appearance of a bubble of electroless copper on the surface of the hole. If present, this defect will typically show up in many locations within a panel.

The typical cause of this defect is poor adhesion of the electroless copper deposit to the hole (epoxy or copper inner layer). The main causes for EB are the same as PL.
